AFWAL-TR-79-3095
VOLUME II

ADVANCED RESIDUAL STRENGTH DEGRADATION RATE
MODELING FOR ADVANCED COMPOSITE STRUCTURES
VOLUME II - TASKS II AND III

Lockheed-California Company
Burbank, California

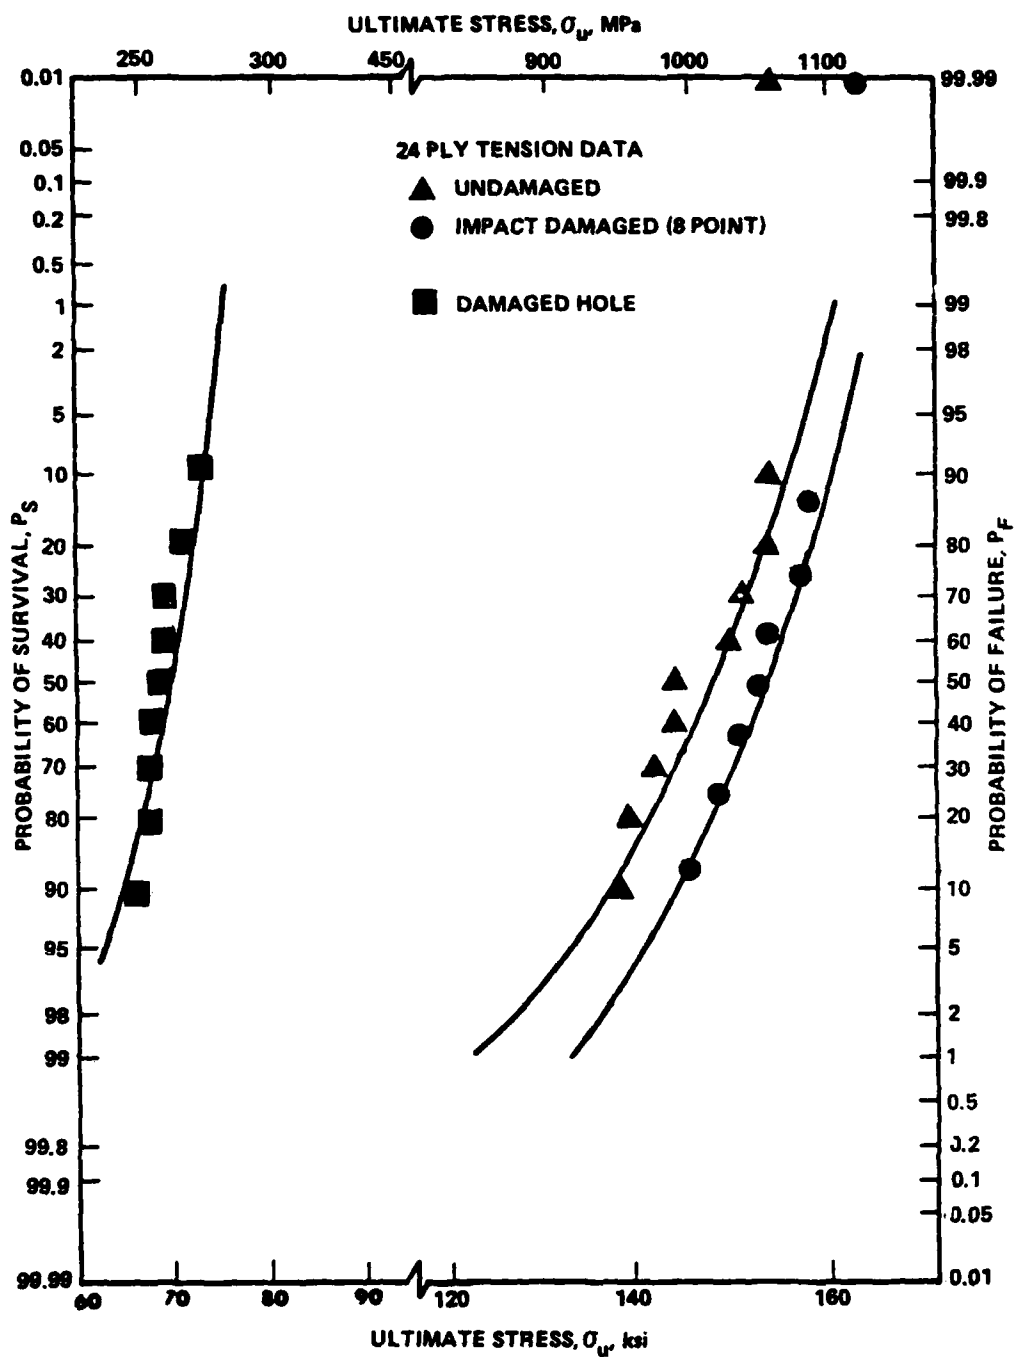
Figure 1: Comparison of the Two-Parameter Weibull Distributions for Tension Test Results of Undamaged, Impact Damaged, and Damaged Hole 24-Ply Laminates

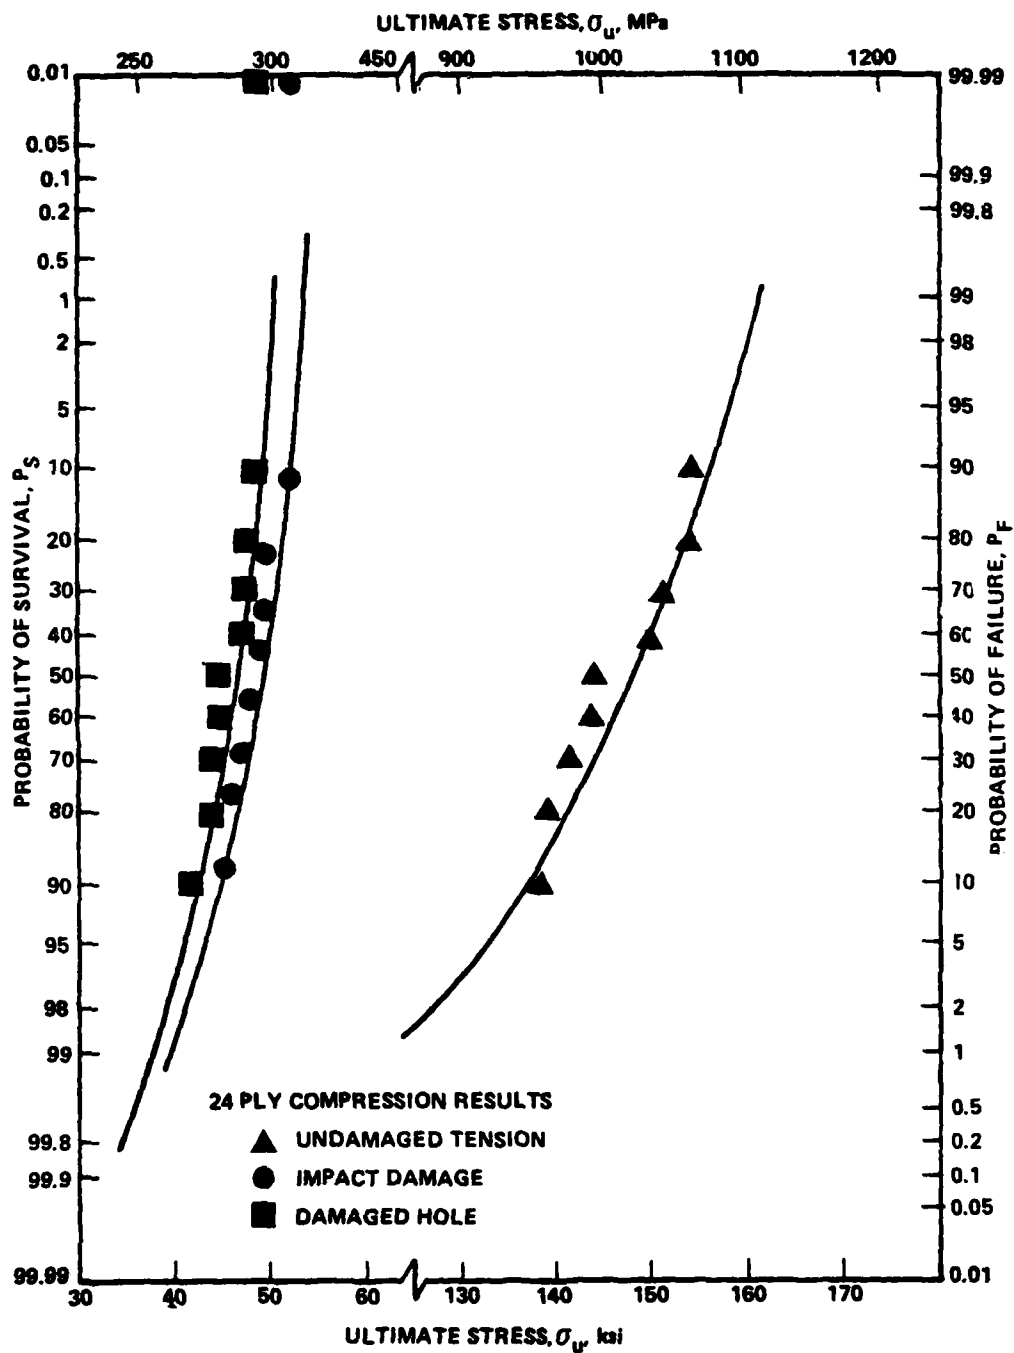
Figure 2: Comparison of the Two Parameter Weibull Curve Fit for Damaged 24-Ply Laminates

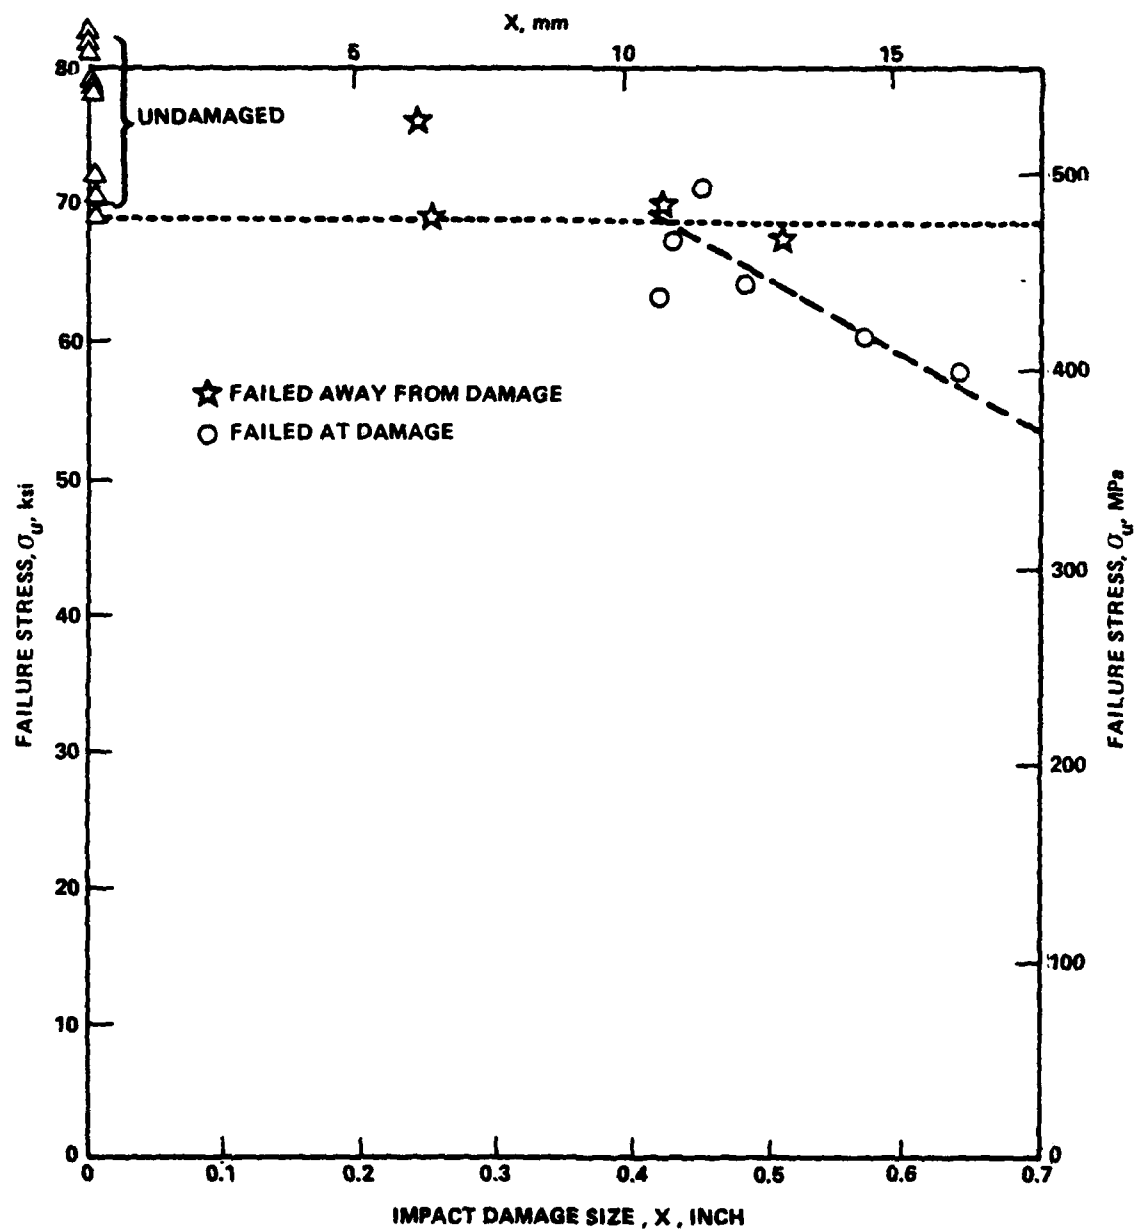
Figure 3: Correlation of Tension Strength with Damage Size for Impact Damaged 32-Ply Laminates.

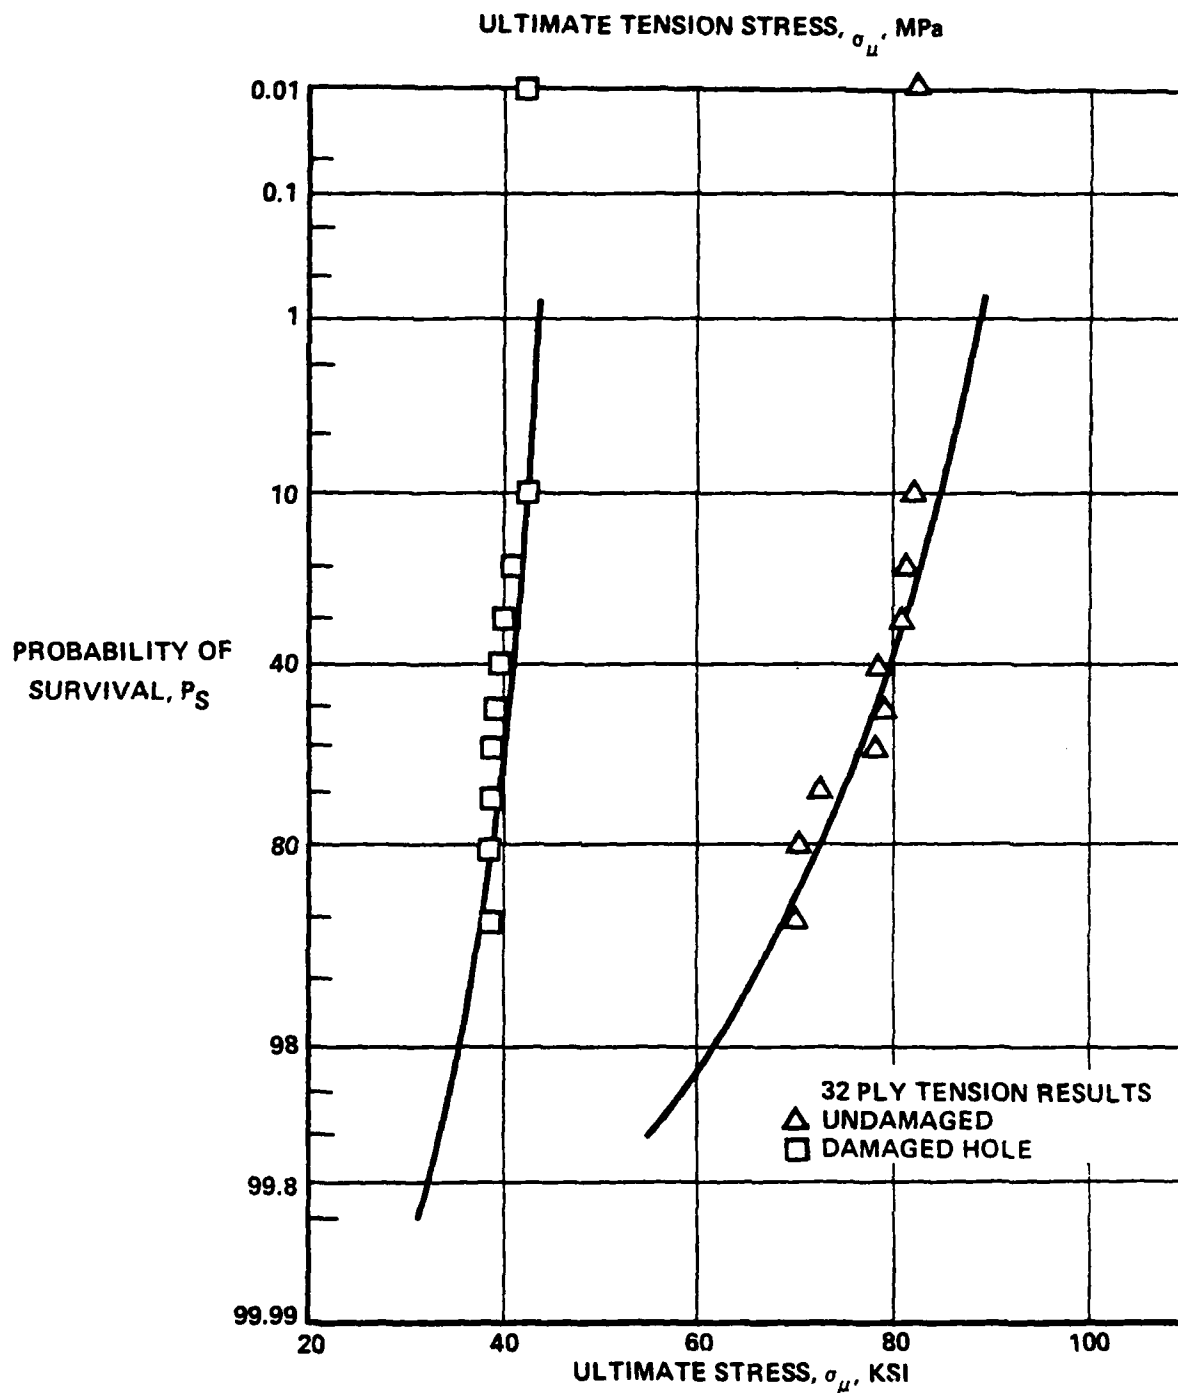
Figure 5: Two Parameter Weibull Curve Fit for Undamaged and Damaged Hole Specimens of 32 Ply Laminate

For the 32 ply quasi-isotropic laminate specimens, the inflicted impact damage was near the threshold size necessary to produce failure through the damage region. Failure typically occurred through regions away from the damage for the lower range of existing damage sizes as evident in Figure 3. For the upper range of impact damage sizes, the tension strength appeared to be very sensitive to the damage size. Under compression loading, the impact damage effected an approximately 30% reduction in static compression strength compared to undamaged tension as displayed in Figure 4. However, the damaged hole produced a more severe drop in the static compression strength (approximately 54%) than the impact damage. Damaged hole static tension data were extremely consistent (low scatter) and well below (approximately 50%) strengths obtained for the undamaged laminate (Figure 5).

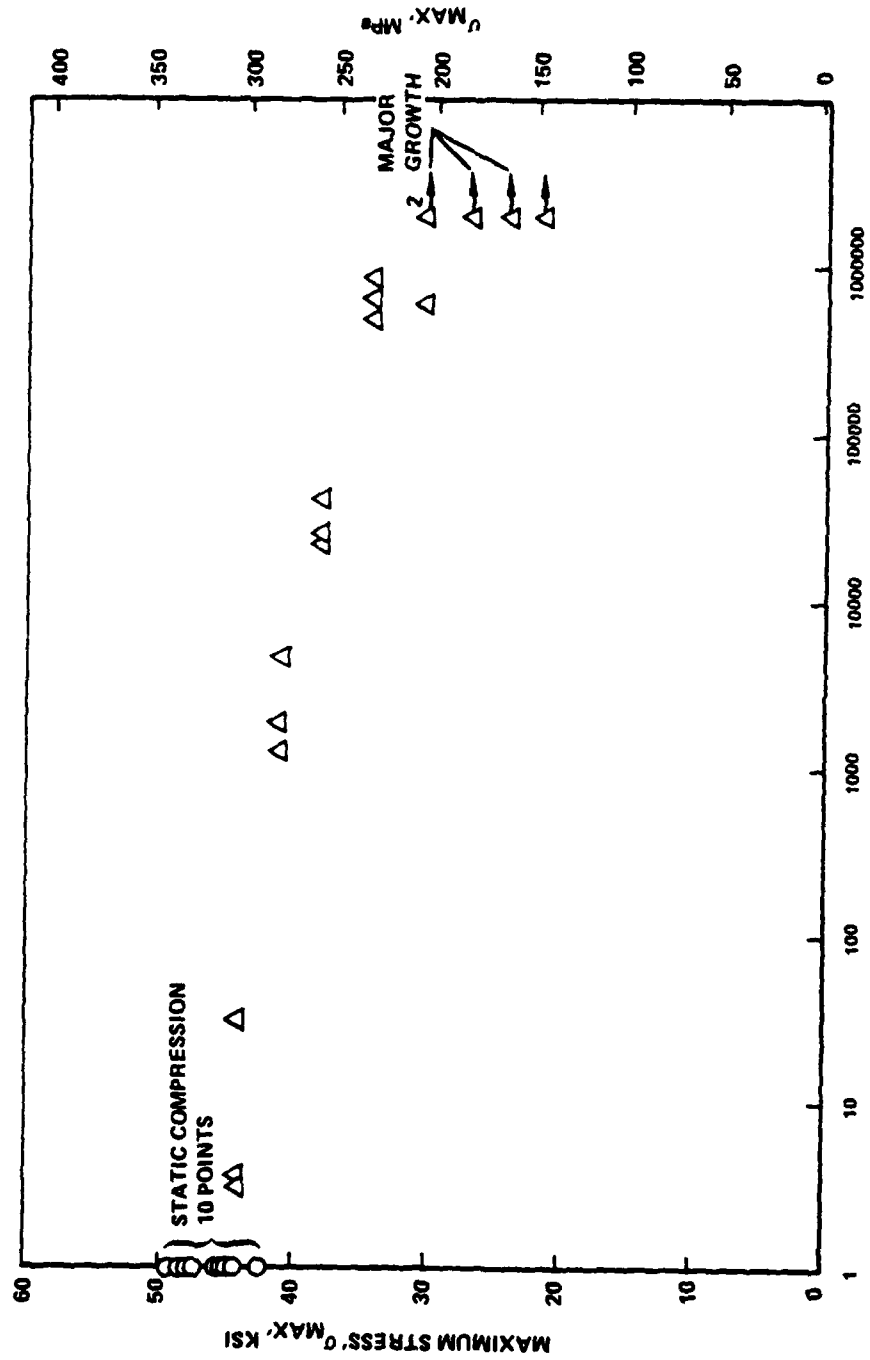
Figure 6: Fatigue Life Data for Damaged Hole Specimens of 24 Ply, 67% 0° Laminate, $R = -1$, 5 Hz

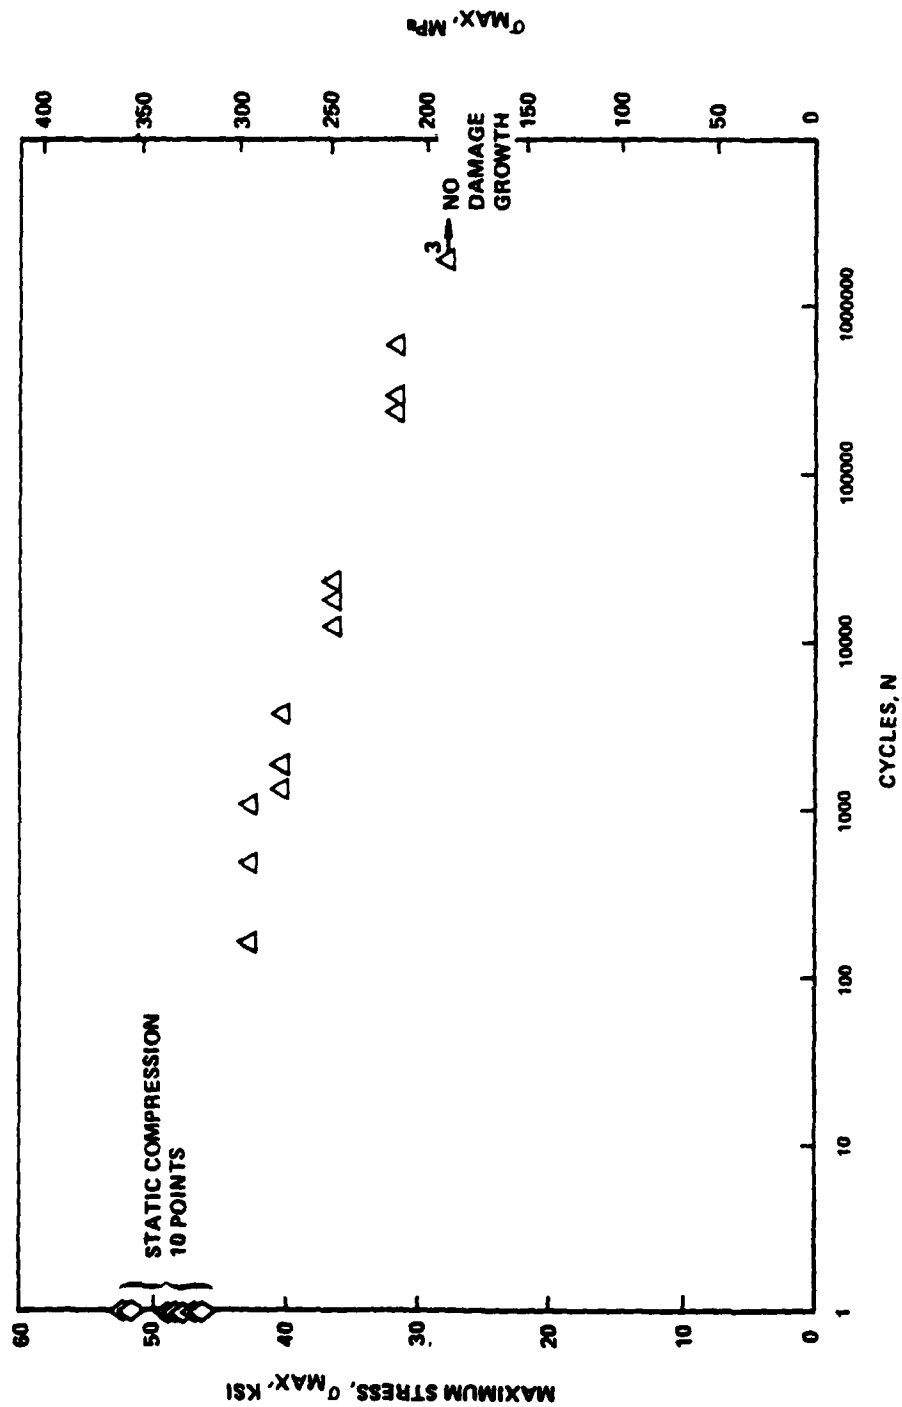
Figure 7: Fatigue Life Data for Impact Damaged 24-Ply, 67% 0° Laminates, $R = -1$, 5 Hz

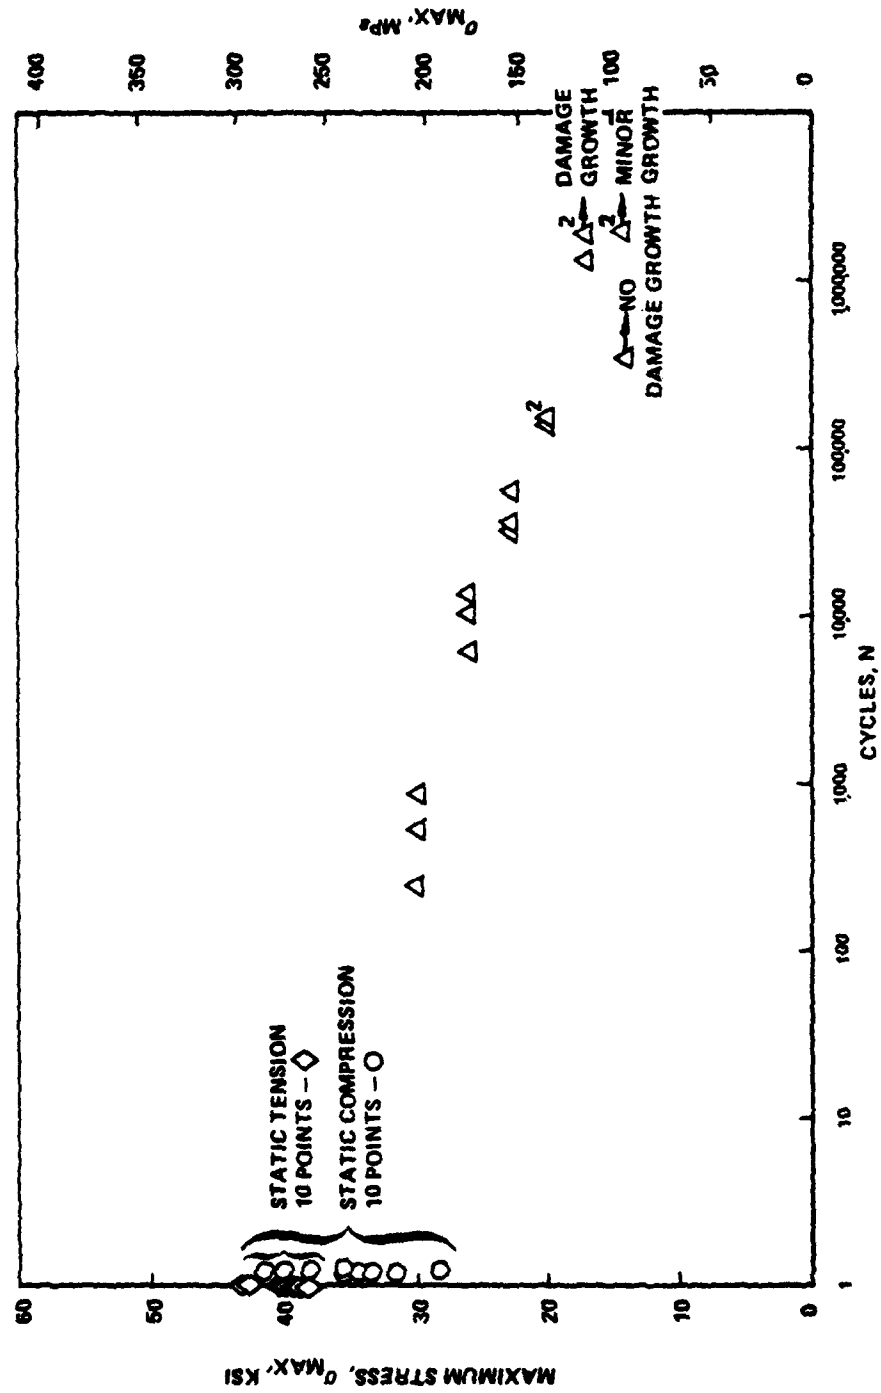
Figure 8: Fatigue Life Data for Damaged Hole 32-Ply Quasi-Isotropic Laminates, $R \approx -1$, 5 Hz

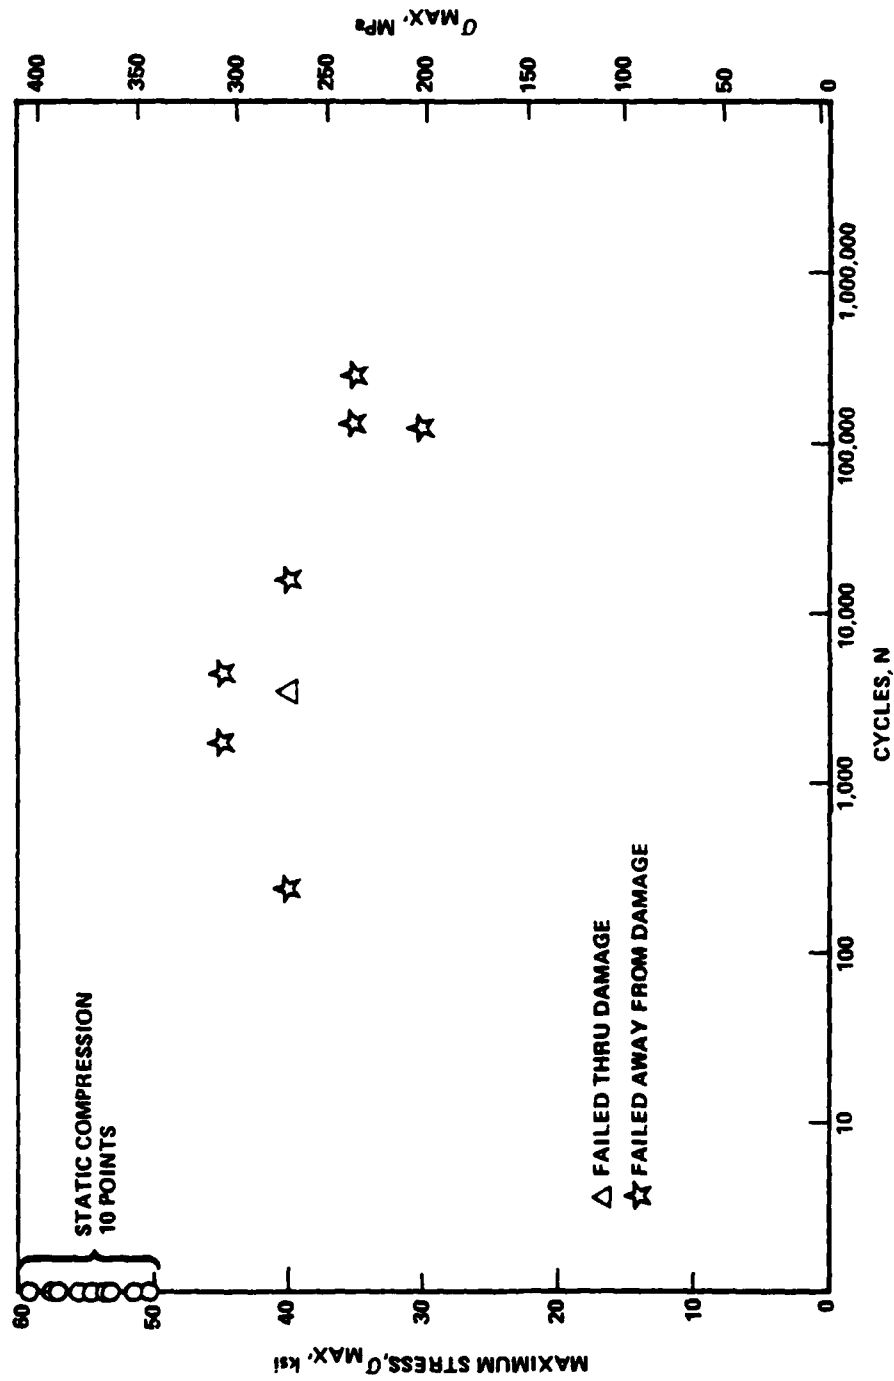
Figure 9: Fatigue Life Data for Impact Damaged Specimens of 32-Ply Quasi-Isotropic Laminates, $R = -1,5$ Hz

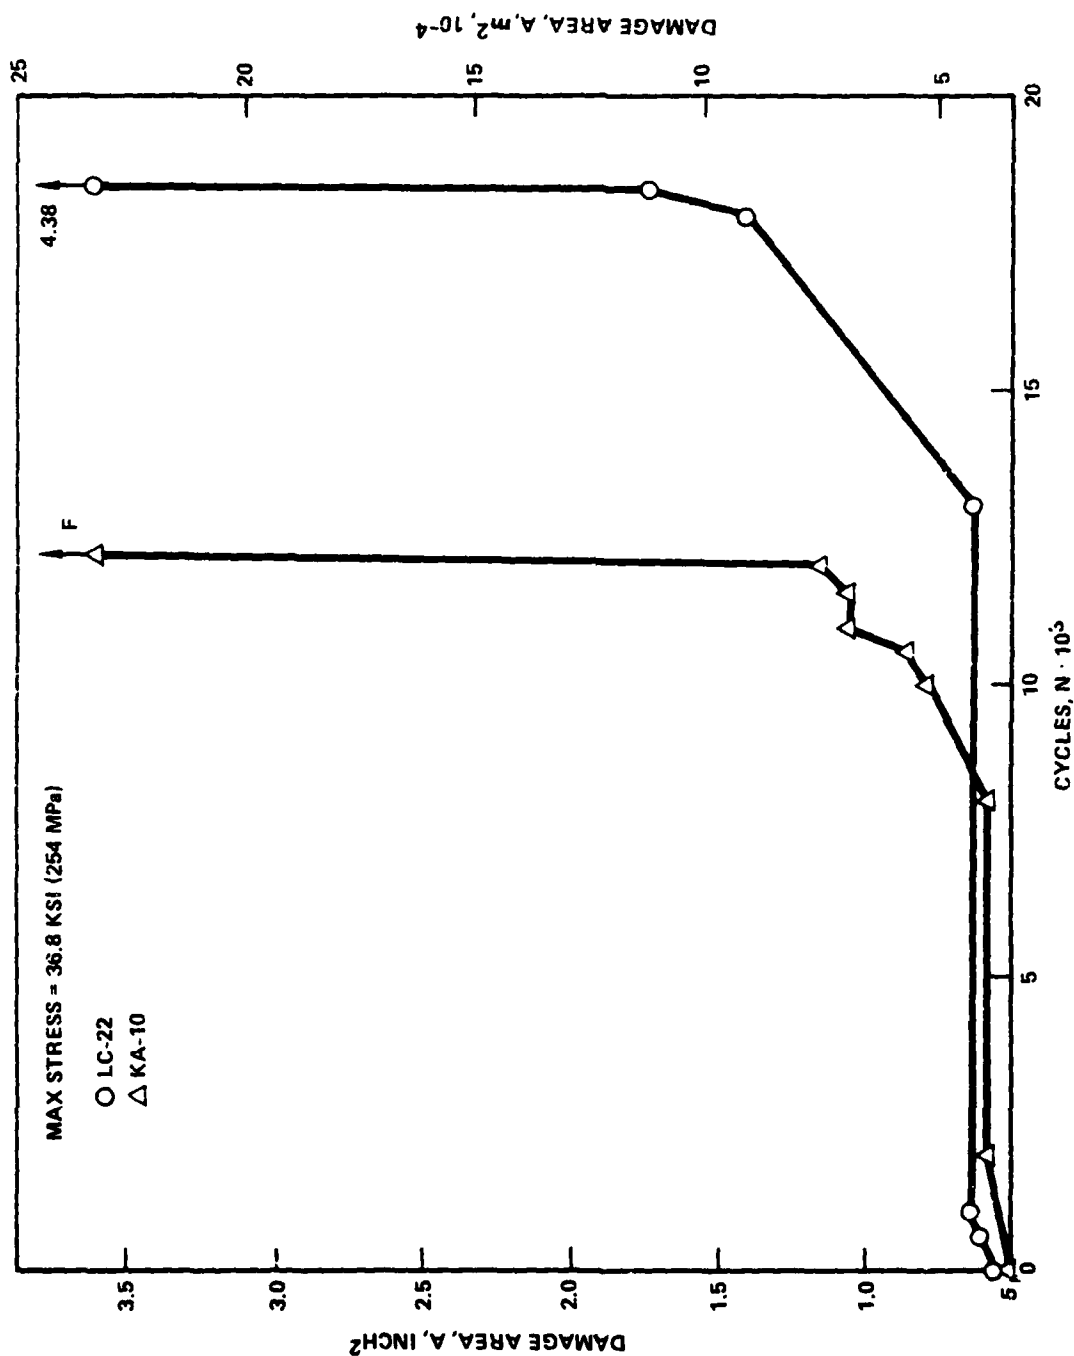
Figure 10: Damage Growth Characteristics of Impact Damaged 24-ply 0° Laminates Specimens, 72°F (21°C), R = -1, Max Stress = 36.8 ksi (254 MPa)

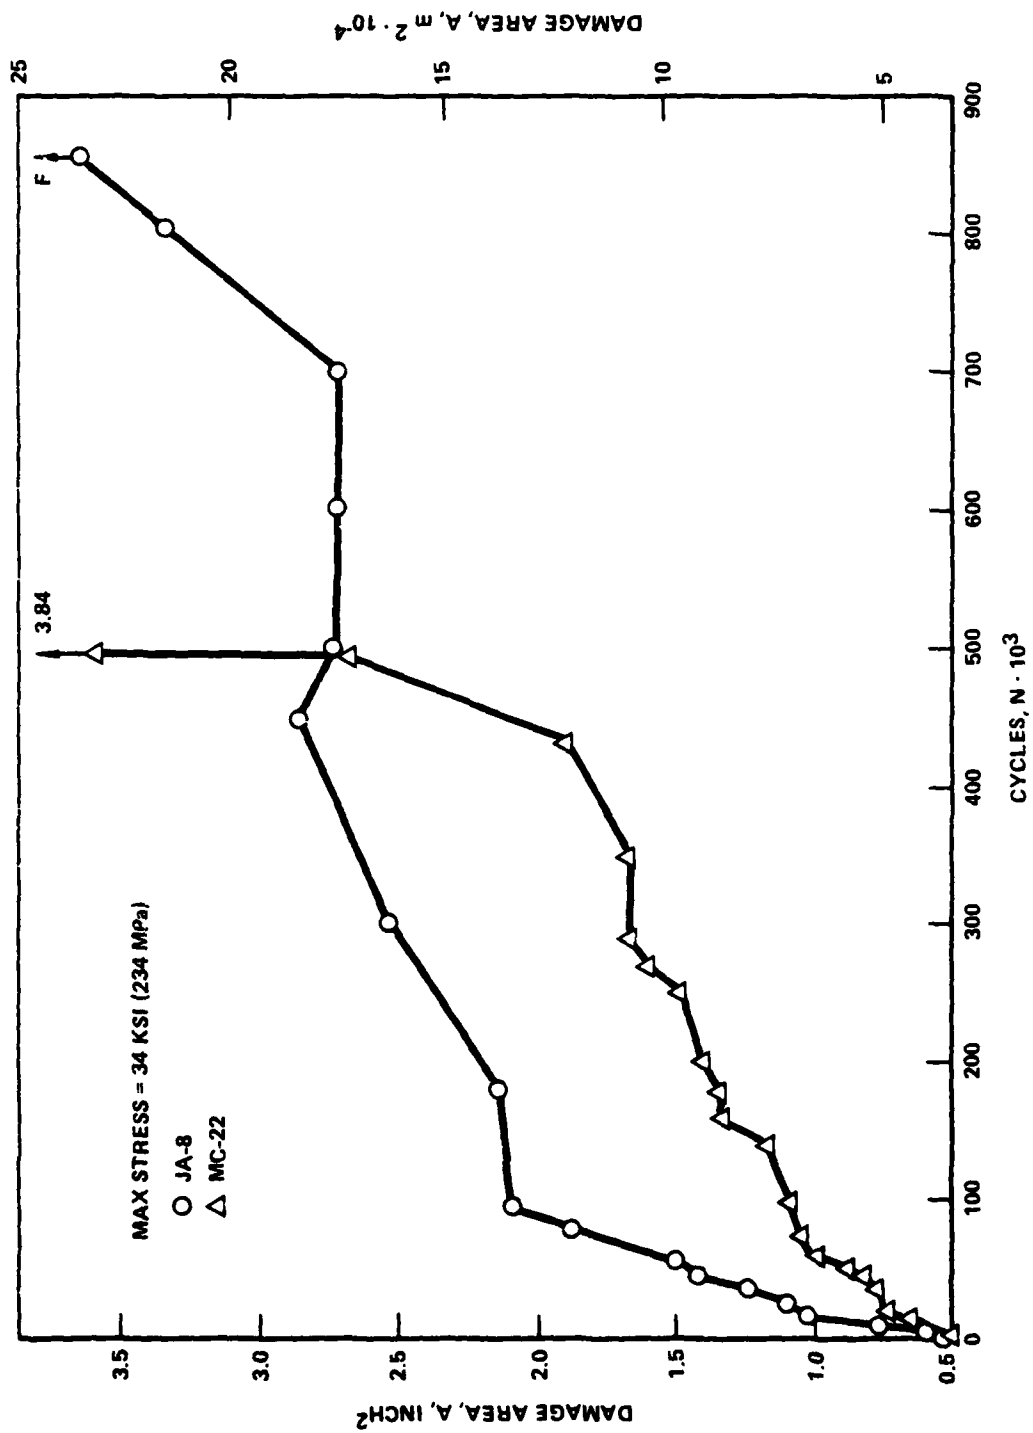
Figure 11: Damage Growth Characteristics of 24-ply 67% 0° Laminate Specimen Containing a Damaged Hole. 72°F (21°C), R = -1, Max Stress = 34 ksi (234 MPa)

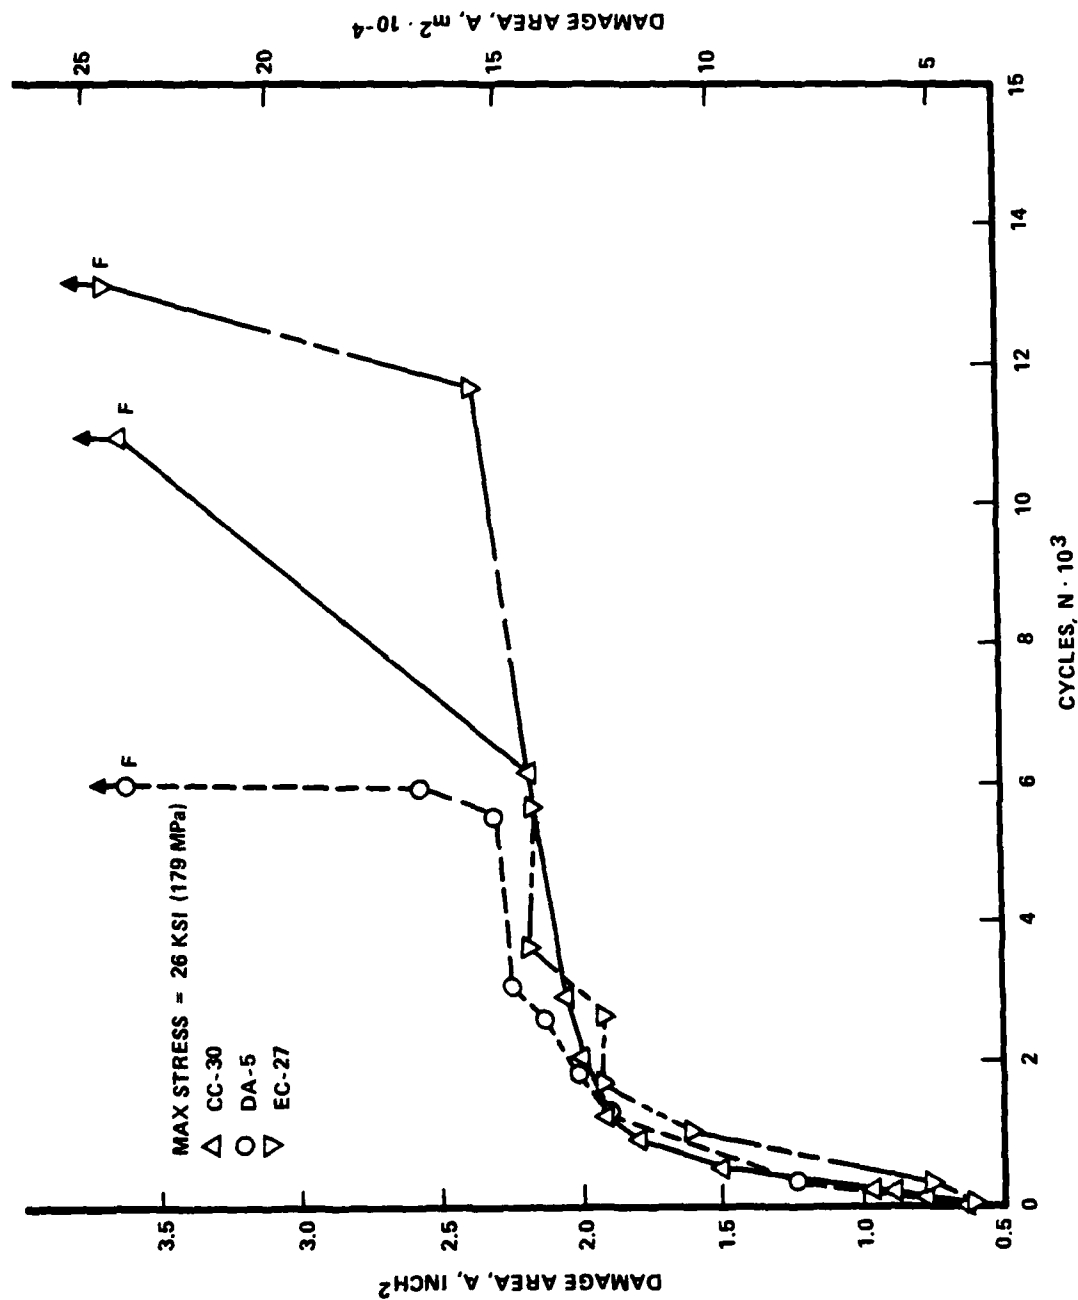
Figure 12: Damage Growth Characteristics of 32-Ply Quasi-Isotropic Laminate Specimens Containing a Damaged Hole. 72°F (22°C), R = -1, Max Stress = 26 ksi (179 MPa)

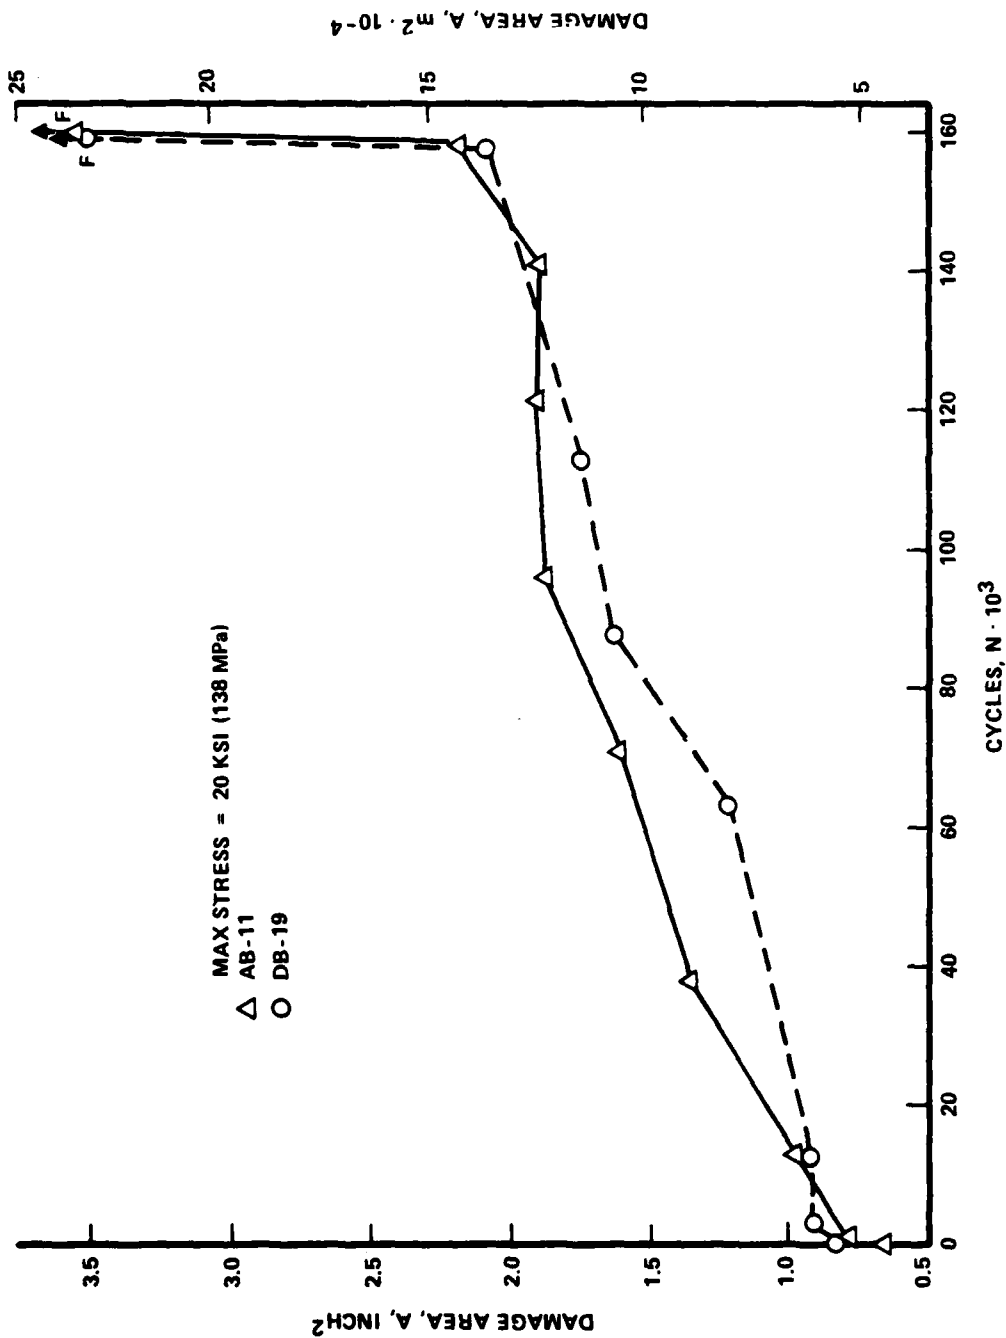
Figure 13: Damage Growth Characteristics of 32-Ply Quasi-Isotropic T300/5208 Laminate Specimens Containing a Damaged Hole. 72°F (22°C), R = -1, Max Stress = 20 ksi (138 MPa)

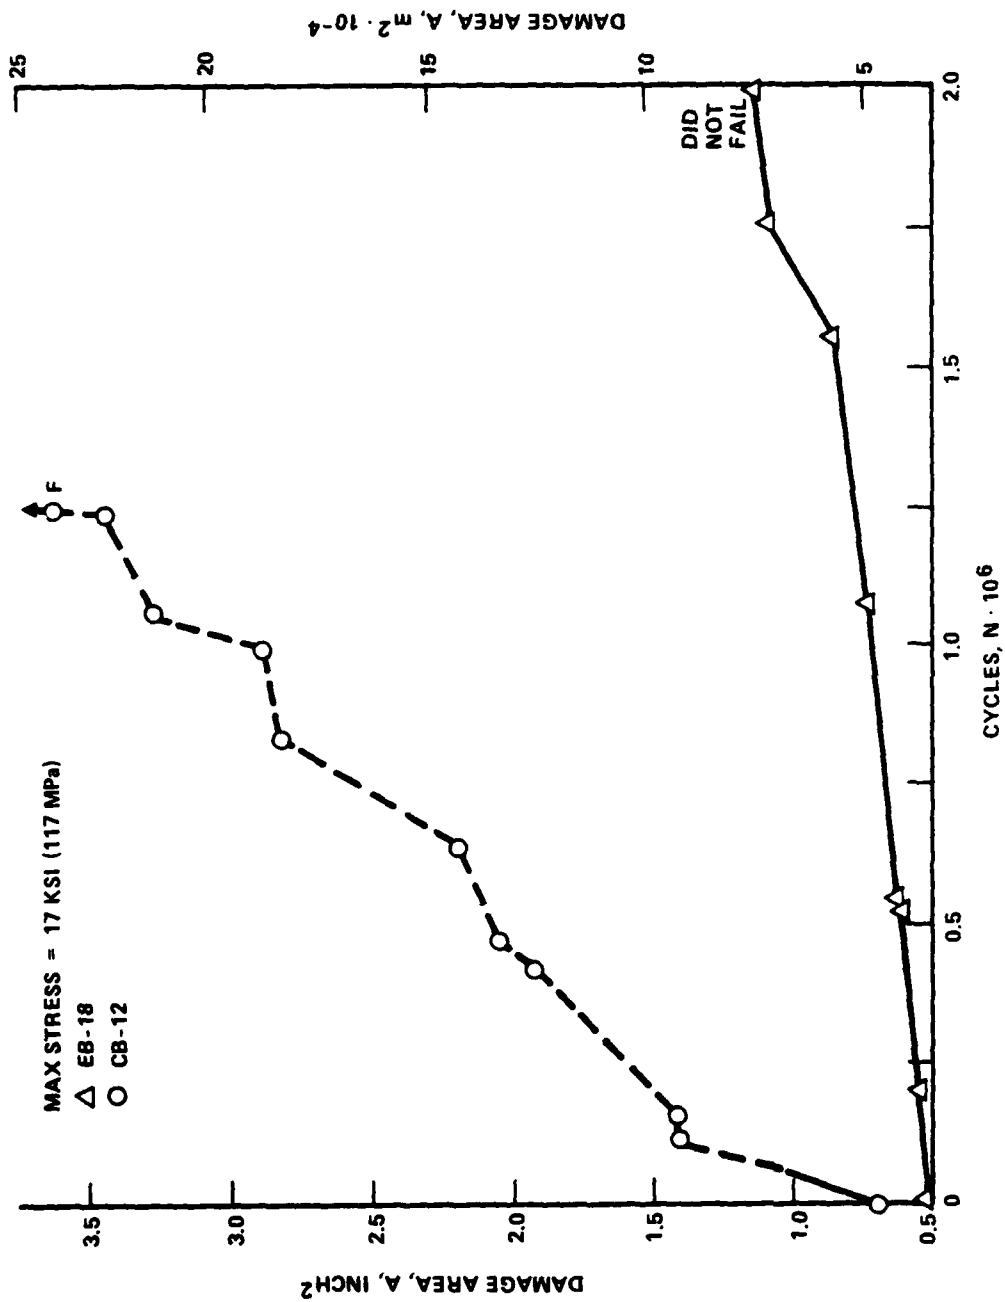
Figure 14: Damage Growth Characteristics of 32-ply Quasi-Isotropic Laminate Specimens Containing a Damaged Hole. 72°F (22°C), R = -1, Max Stress = 17 ksi (117 MPa)

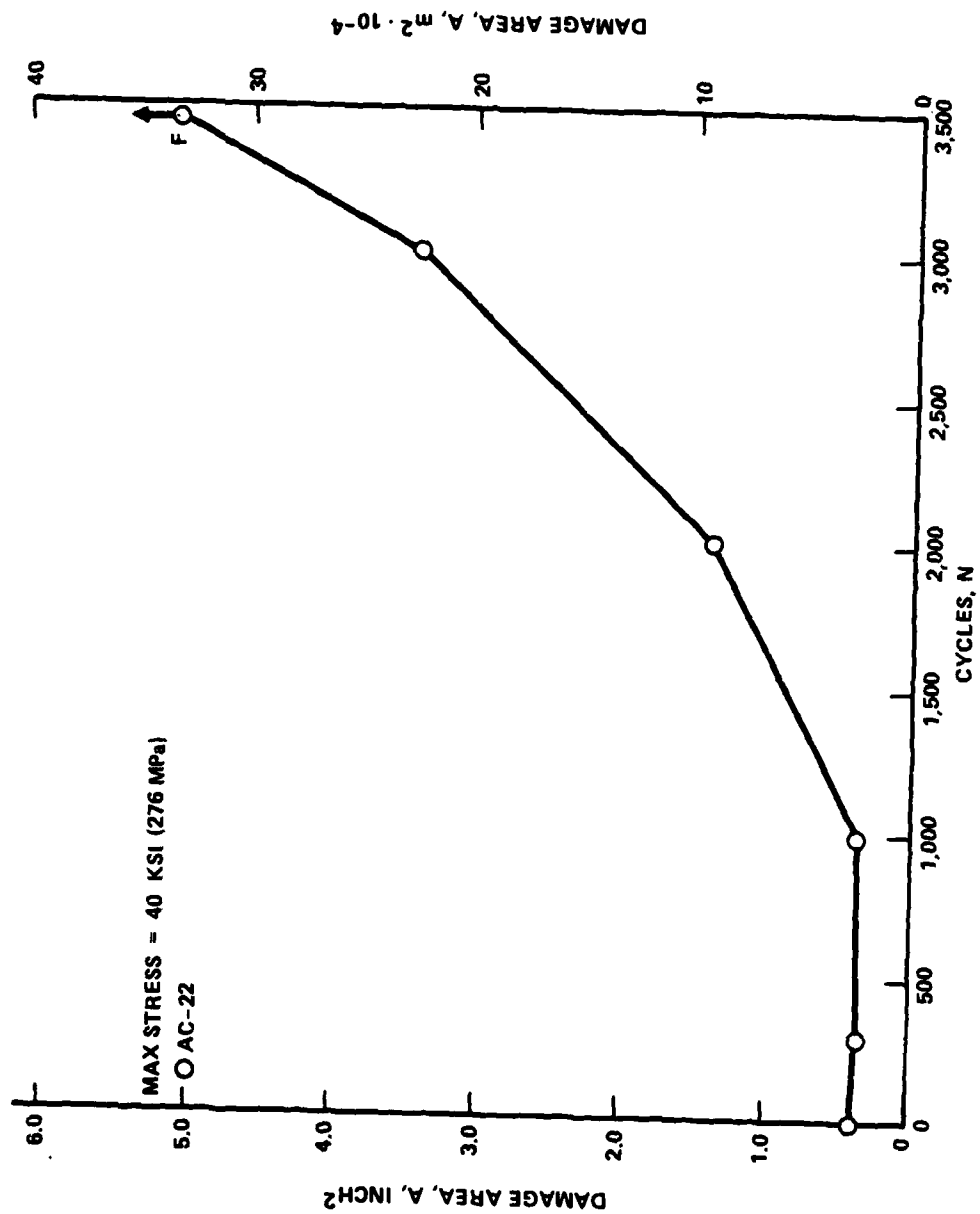
Figure 15: Damage Growth Characteristics of 32-Ply Quasi-Isotropic Laminate Specimens Containing Impact Damage 72°F (20°C), R = -1, Max Stress = 40 ksi (276 MPa)

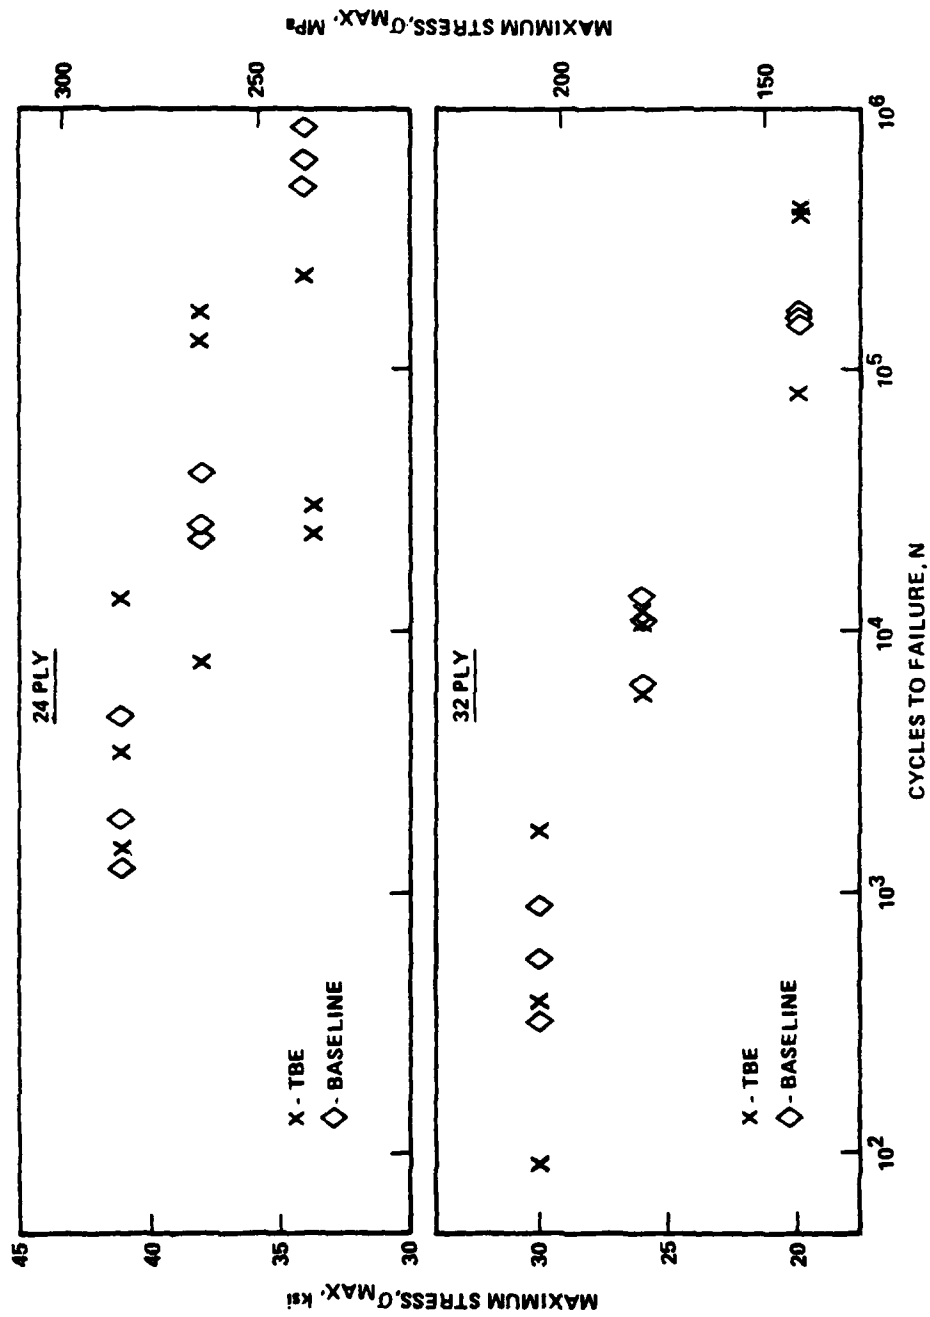
Figure 16: Comparison of Baseline and TBE Exposed Specimen Fatigue Results, $R = -1$, 5 Hz

measurable effect on the subsequent fatigue behavior of the 32-ply laminate, but results were less definitive for the 24-ply laminate where there is a slight indication of a possible shortening of the fatigue life at lower stresses. However, the limited sample size is small enough that the apparent reduction probably results from the inherent scatter under fatigue loading. A comparison of baseline and TBE exposed specimen fatigue results is presented in Figure 16.

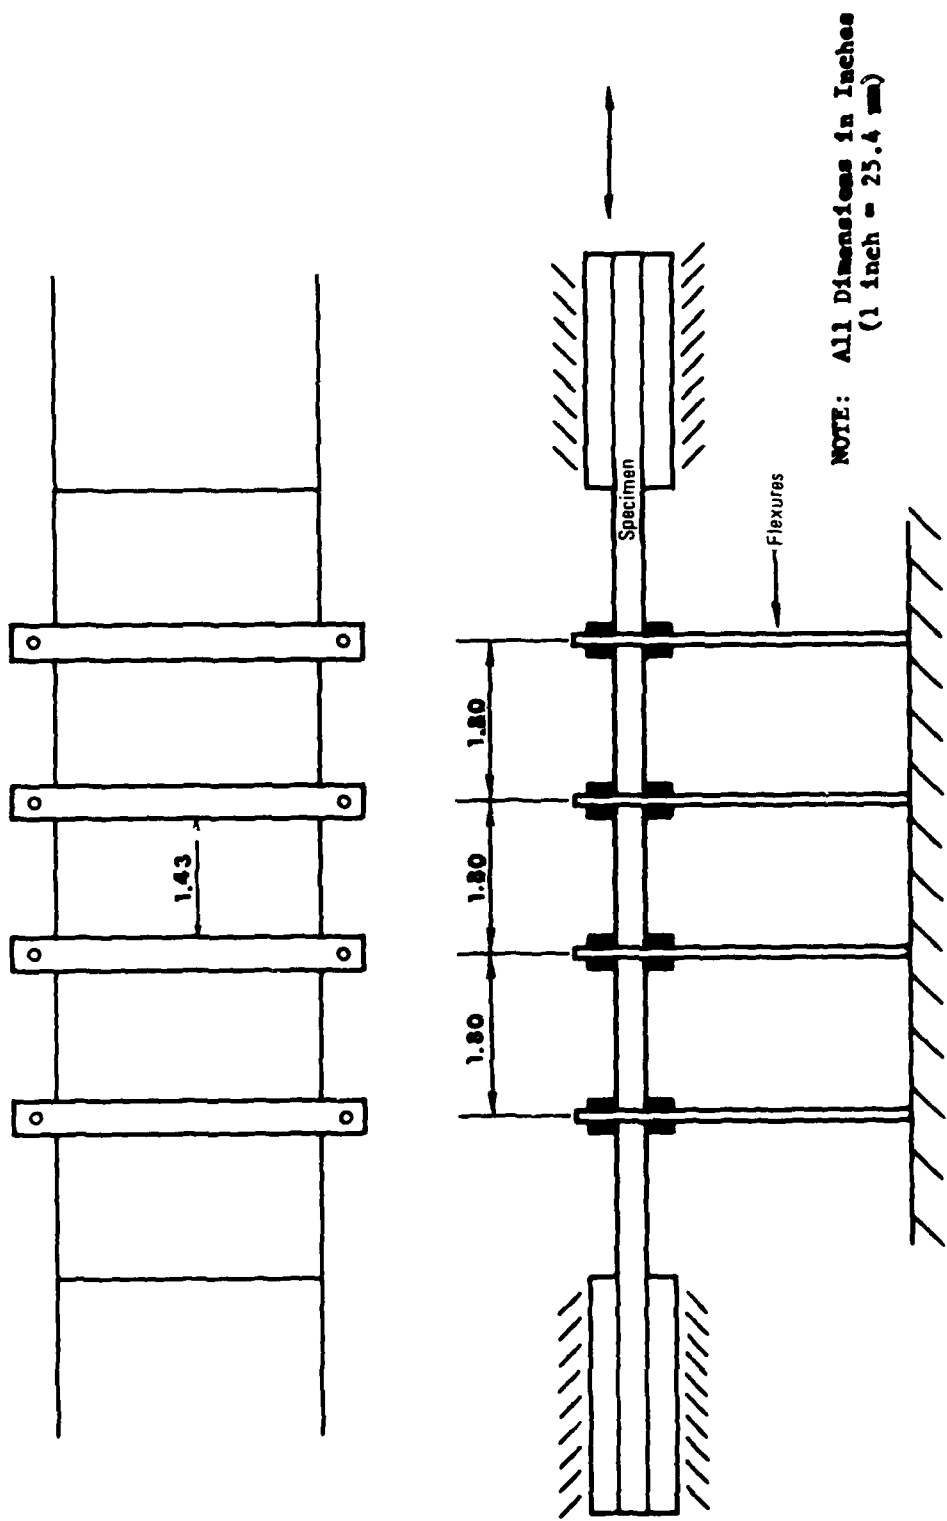
Figure 21: Four-Bar Buckling Support (Constraint Condition #2) Design
